Durability of Posttensioned Concrete After 33 Years of Marine Exposure

Technical Report SL-97-9
September 1997

by Morris Schupack

Final report

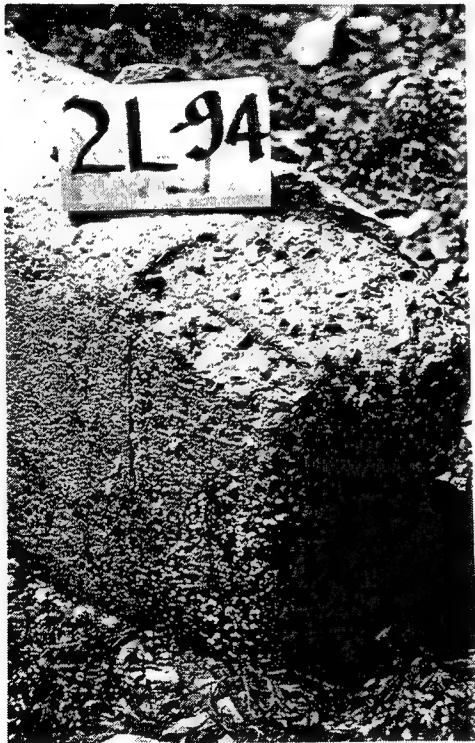
Fig. 5-3K

1. Surface preparation - bush hammer, 4 ends (Fig. 5-3K).
 - a) Two failed in 1978.
 - b) Other two in good condition as of 1994.
2. Surface preparation - none, 4 ends.
 - a) Two failed.
 - one in 1978.
 - one in 1994.
 - b) Two in good condition as of 1994.

Beam 2 - Landward end - 1994

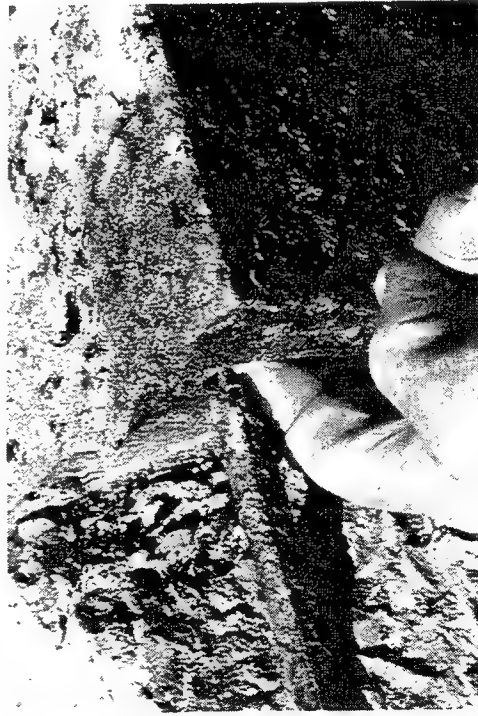
Fig. 7-2G

The only complete wasting of reinforcing steel that has occurred are those that were contiguous to and in epoxy-resin concrete. Figure 7G through 7L and 8B through 8G shows similar performance. The rebars penetrating the epoxy were destroyed to an unknown depth into the end cap and the bar adjacent to the epoxy-resin concrete interface also was completely corroded and had spalled the concrete off. The reason for this type of complete dissolution of the reinforcing steel is not fully understood. A possible explanation for this is the far superior electrical isolation of the epoxy concrete compared to the portland-cement concrete and the consequent large cathode-small anode corrosion cell. It is also possible that once the interface between the epoxy resin and the concrete suffered concrete deterioration, the reinforcing steel progressively corroded inward toward the body of the epoxy resin. A further study of some of the remaining beams may reveal the reasons for this more aggressive corrosion and the progression of the rebar corrosion into the epoxy-resin concrete.

Beam 12- Landward end - 1980

Rebar corrosion into epoxy end protection

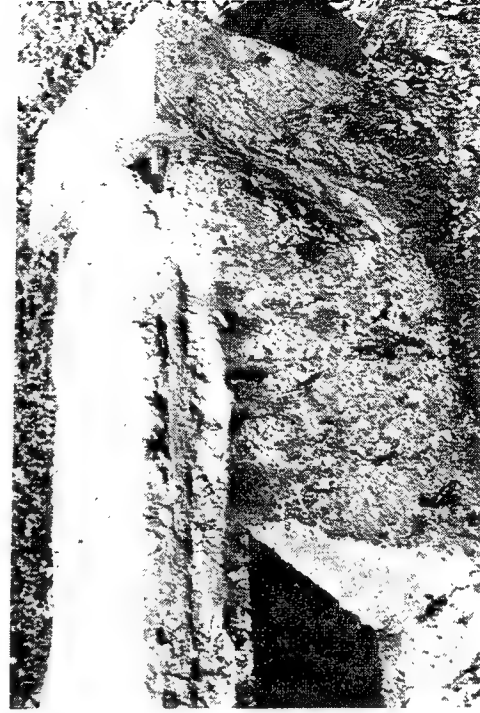
Beam 12 - Landward end - 1980

Edge spalling and rebar corrosion

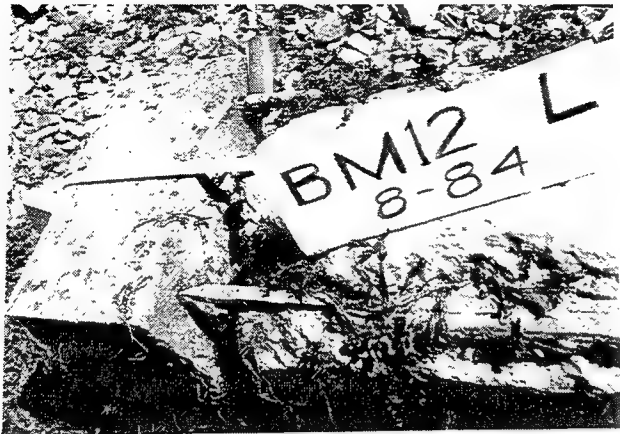
Beam 12 - Landward end - 1984
Corrosion of rebar
Fig. 7-3I

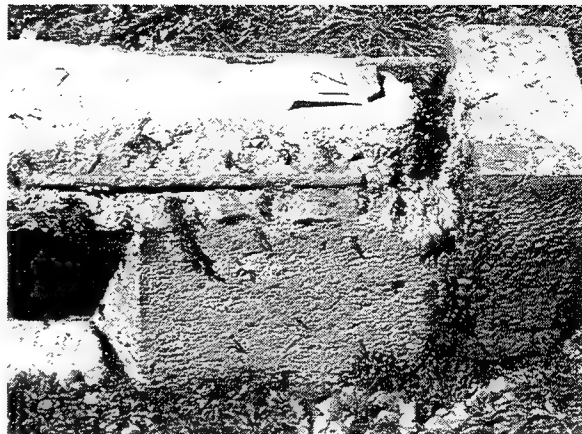
Beam 12 - 1988
Epoxy end cap and rebar corrosion
Fig. 7-3J

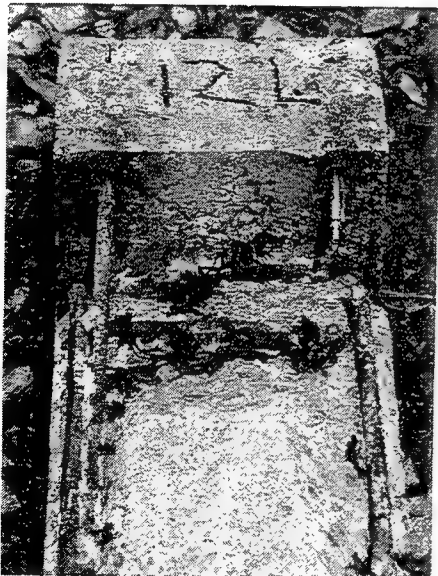
Fig. 7-3K

Beam 12 - Landward end - 1994
Concrete and rebar deterioration

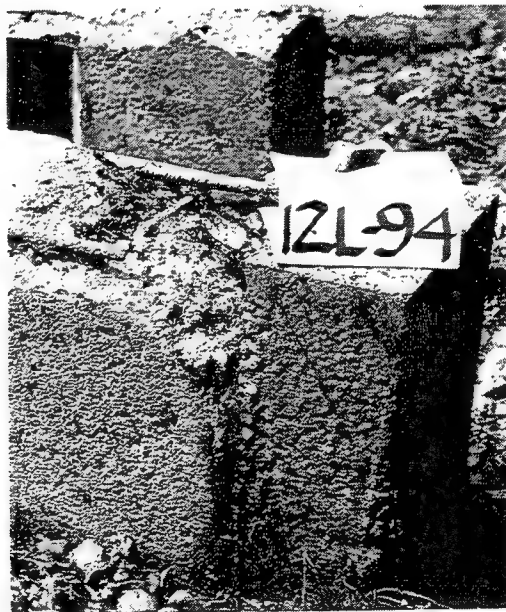
Fig. 7-3L

Beam 12 - Landward end - 1994
Concrete and rebar deterioration

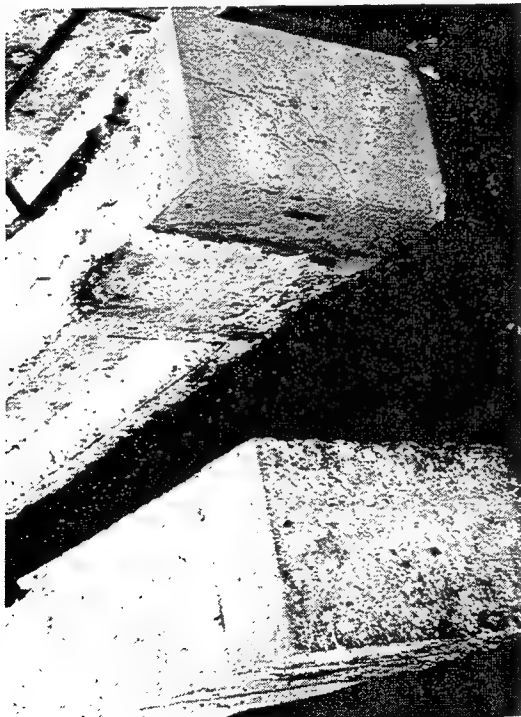
Beam 16 - Seaward end - 1972
Rebar corrosion
Fig. 8-1A

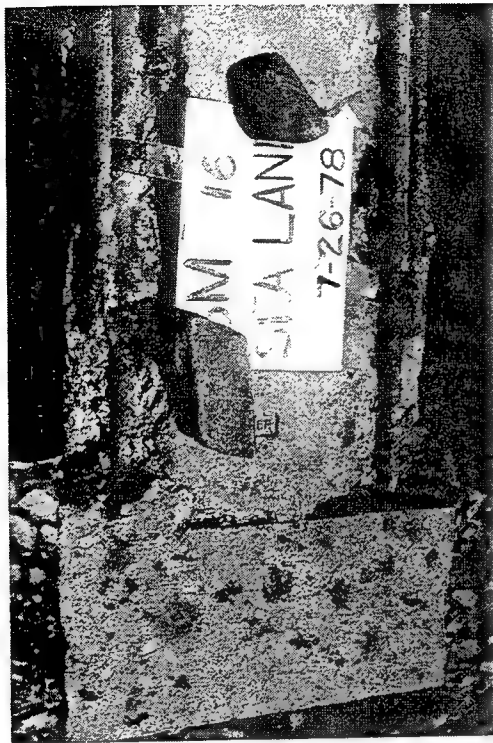
Beam 16 - Seaward end - 1978
Progressive corrosion & spalling
Fig. 8-1B

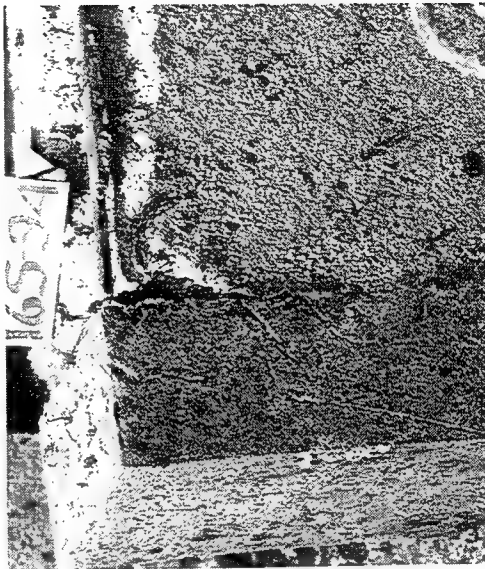
Beam 16 - Seaward end - 1994
Interface failure
Fig. 8-1D

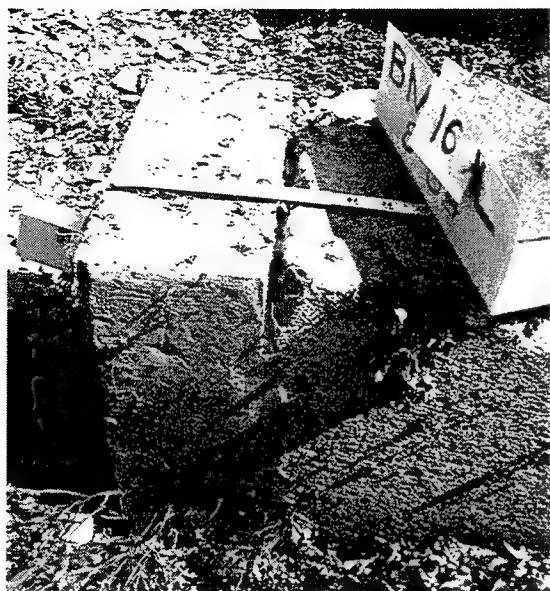
Beam 16 - Landward end - 1984
Concrete interface breakdown
Fig. 8-2E

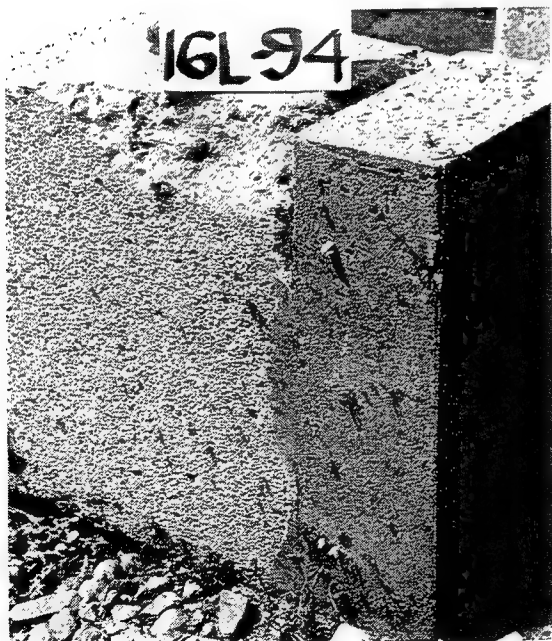
Fig. 8-2G

- A. No reinforcement through cold joint (Fig. 8-2G).
1. Surface preparation - sandblasted, followed by primer - 4 ends.
 - a) Three failed by 1978.
 - b) One autopsied in 1974, good condition.
- B. With reinforcement through cold joint (Fig. 7-3K).
1. Surface preparation - sandblasted, followed by primer - 4 ends.
 - a) Three failed by 1982.
 - b) One autopsied in 1974, good condition.

Beam 16 - Landward end - 1994

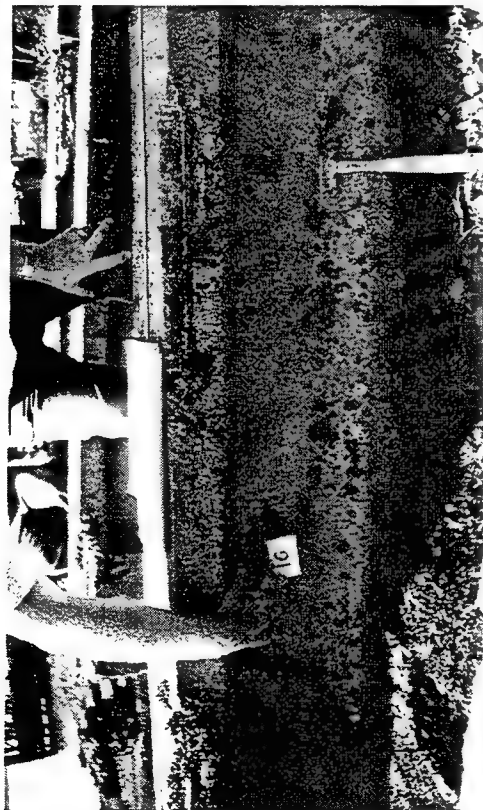
Beam 16 - 1984
First indication of stirrup corrosion
Fig. 8-3I

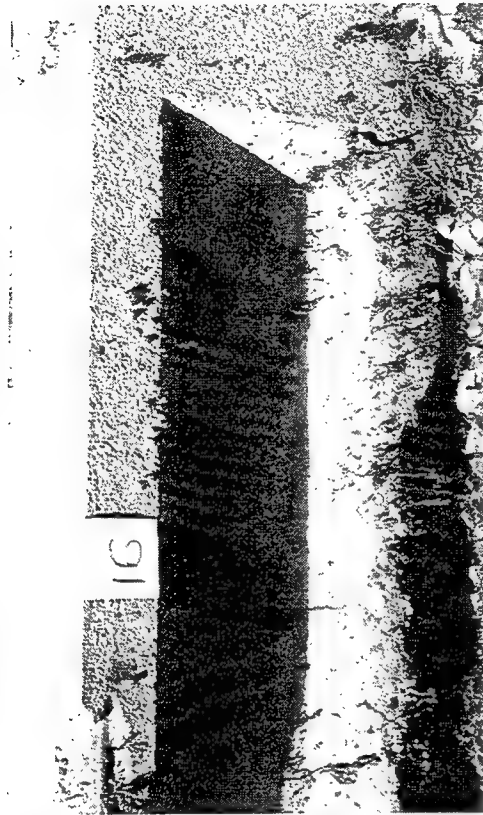
Beam 16 - 1988
Stirrup corrosion has not progressed
Fig. 8-3J

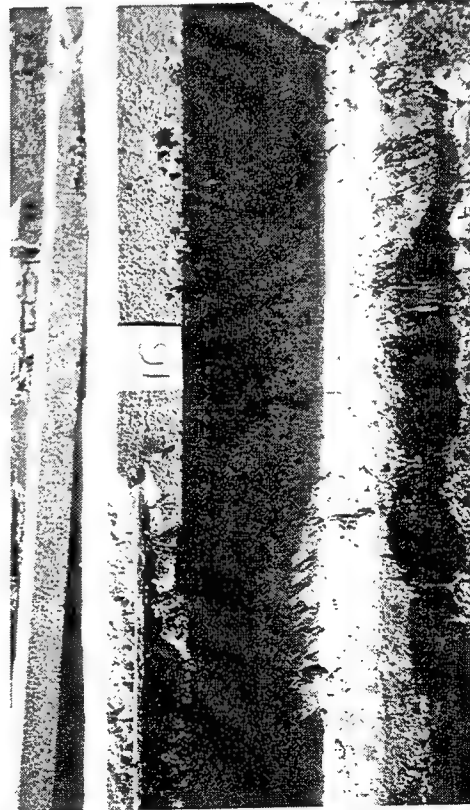
Beam 16 - 1990
Stirrup corrosion
Fig. 8-3K

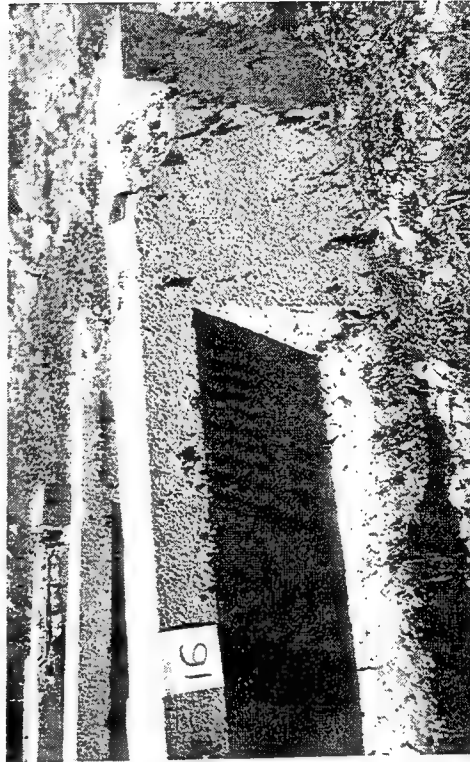
Beam 16 - 1994
Stirrup corrosion
Fig. 8-3L

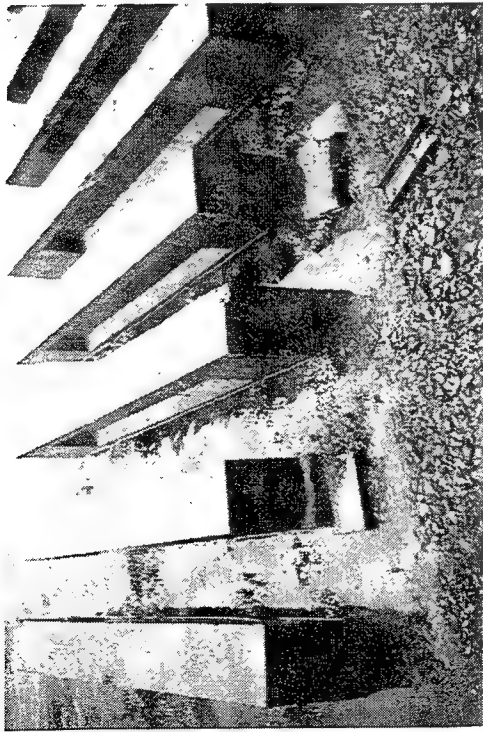
Beam 17 - Seaward end - 1972
End protection failed
Fig. 9-1A

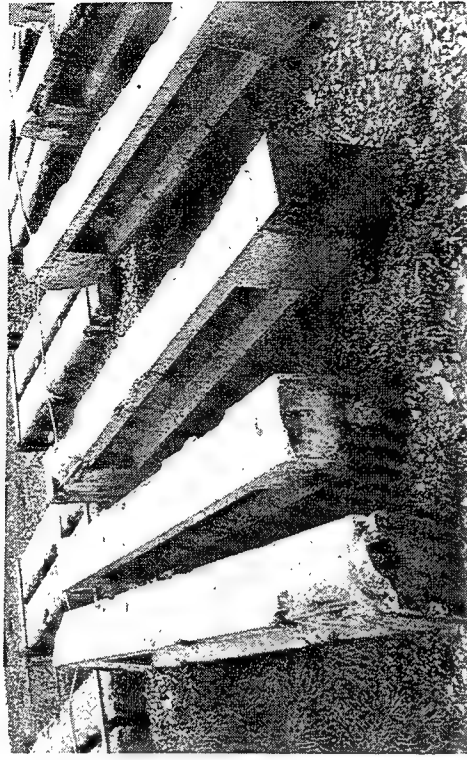
Beam 17 - Landward end - 1976
Edge spall
Fig. 9-1B

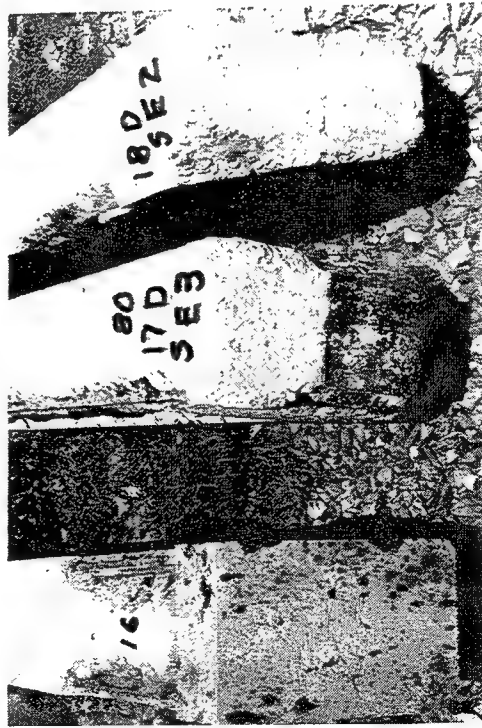
Beam 17 - Seaward end - 1980
Failed 1963
Fig. 9-1C

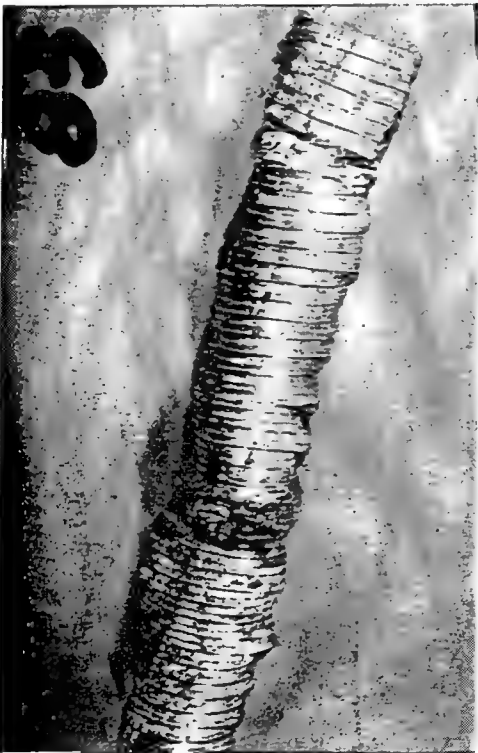
Beam 17 - Outside - 1984
Post-tensioning conduit corrosion
Fig. 9-3I

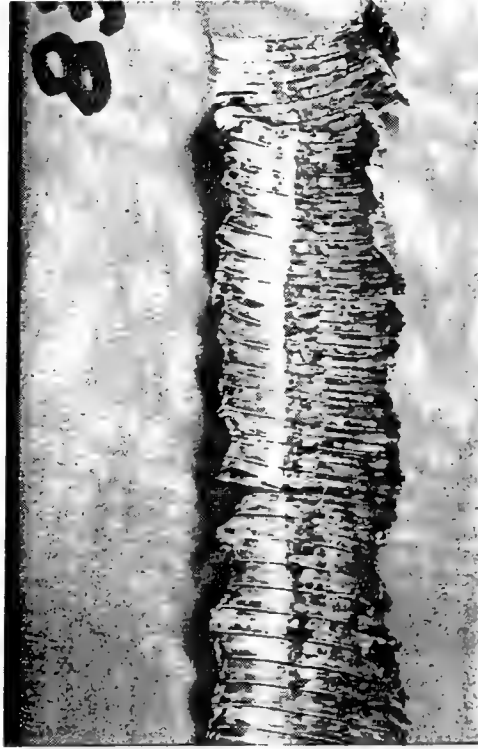
Beam 17 - Inside - 1984
Post-tensioning conduit corrosion
Fig. 9-3J

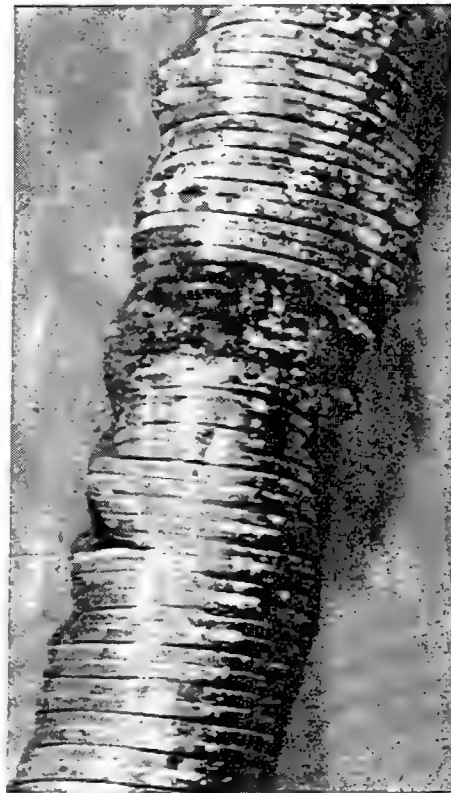
Beam 17 - Post-tensioning conduit corrosion - 1984
Fig. 9-3K

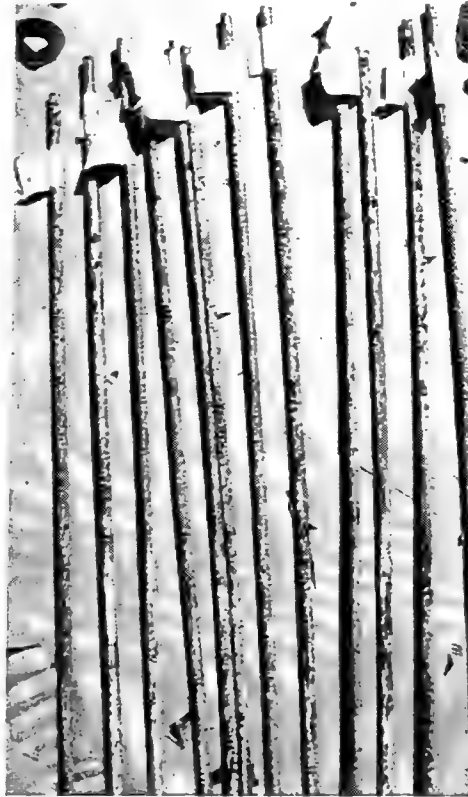
Beam 17 - Prestressing wire corrosion - 1984
Fig. 9-3L

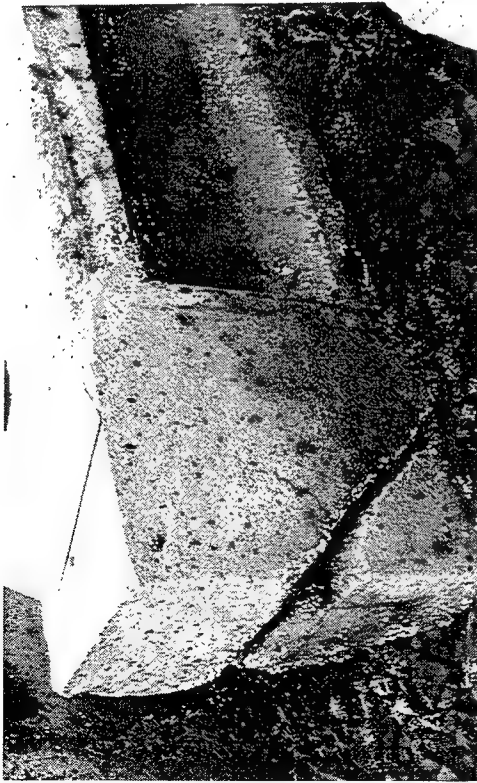
a) One failed in 1972, autopsied in 1983 (Fig. 10-1A).

Beam 4 - Seaward end - 1982
Failed flush epoxy anchorage protection
Fig. 10-1A

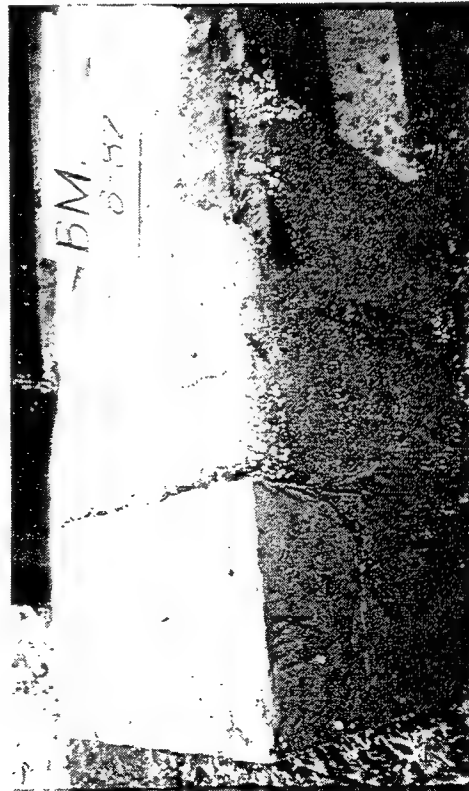
Beam 4 - Landward end - 1982
Epoxy external end protection
Fig. 10-1C

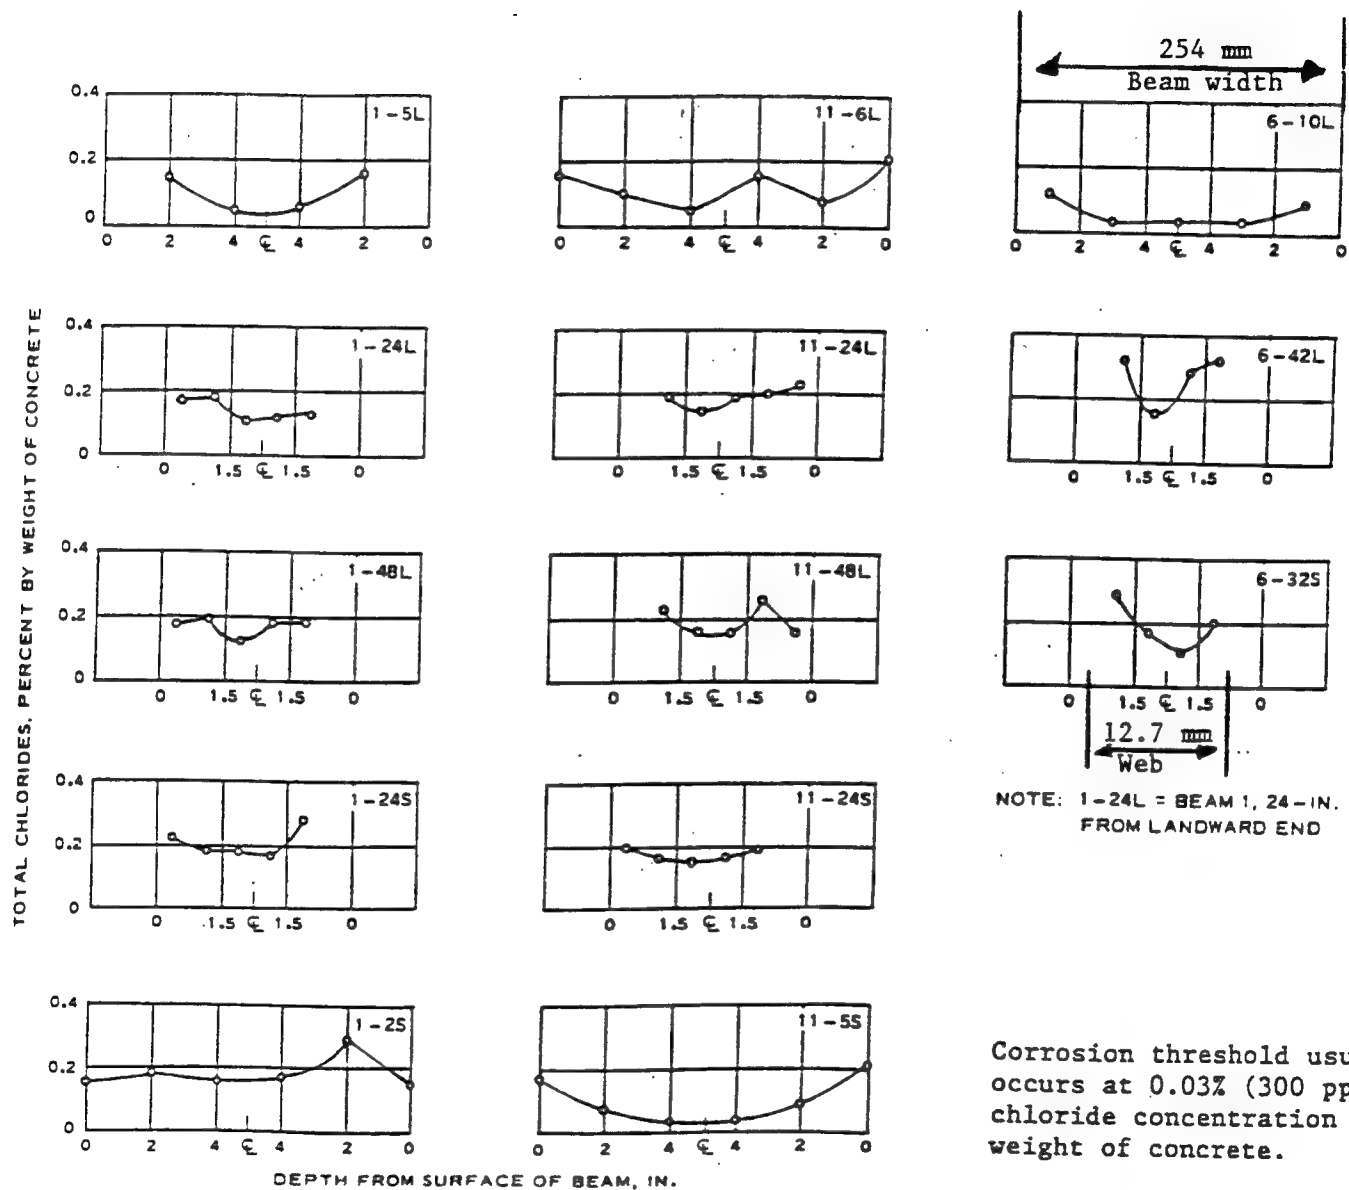
Fig. 11 - Total Chloride Content vs Depth from Vertical Beam Surface

In the 1973-74 autopsies as reported in the WES Report², the chloride gradient through the webs indicated sufficient chlorides to expect that all reinforcement would have been seriously corroded. Figure 11, was extracted from the WES Report and modified to show the chloride threshold at which there is a 90% chance that corrosion will occur. It is surprising that with this amount of chloride contamination found after twelve years, that the remaining nine 33 year old beams show very limited evidence of web stirrup corrosion.

Corrosion threshold usually occurs at 0.03% (300 ppm) chloride concentration by weight of concrete.

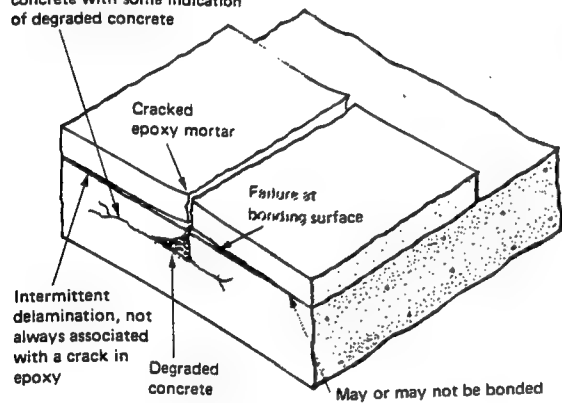
Fig. 12-A

Horizontal crack in concrete with some indication of degraded concrete

Condition of the same concrete and epoxy mortar after several years (Ref. 10)

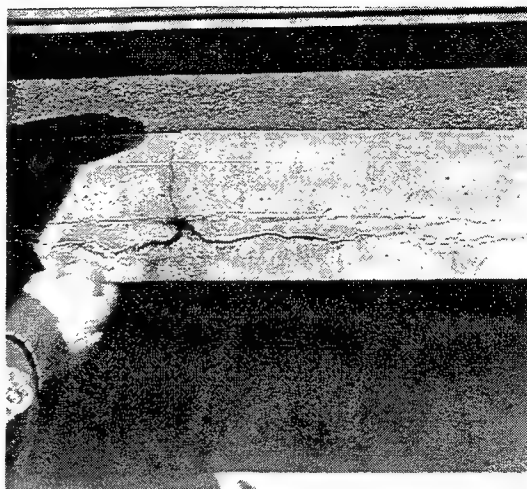
Fig. 12-B Concrete railroad platform with epoxy mortar curb showing concrete deterioration.

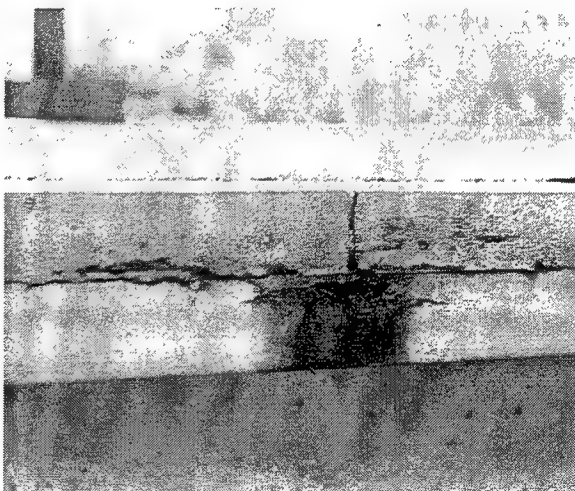
Fig. 12-C Concrete railroad platform with epoxy mortar curb showing concrete deterioration.

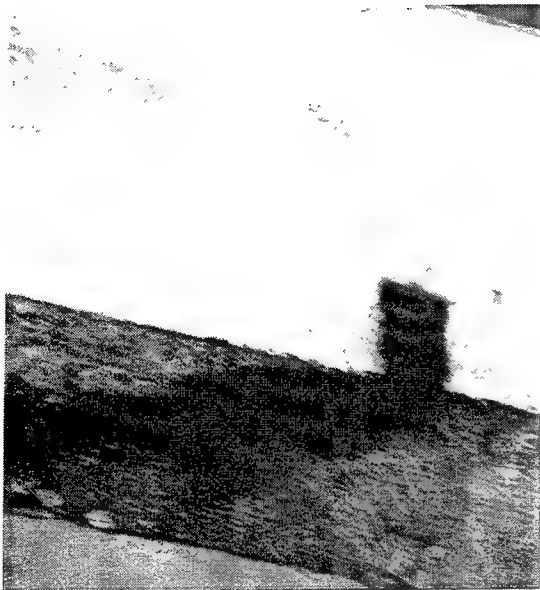
FIG. 13-A

NONE BONDED - MORTAR PERMITTED
WATER ACCESS TO TENDON ANCHOR
WITH RESULTING CORROSION

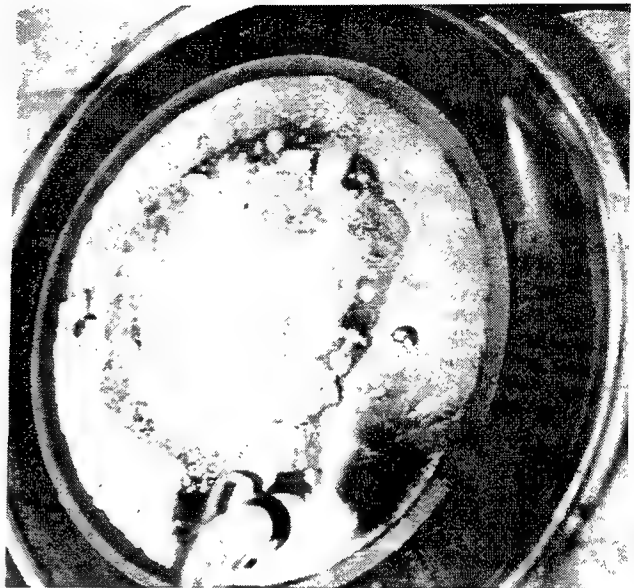
FIG. 13-B

POROUS MORTAR USED IN POCKET
DETECTED BY A BUBBLE VACUUM
TEST
